# Manhole Inspection Summary

Manhole # S17E1\_016MH

Insp Date: **5/1/09 2:08 PM**

**Location** Address: **2865 MAUDLIN AV**

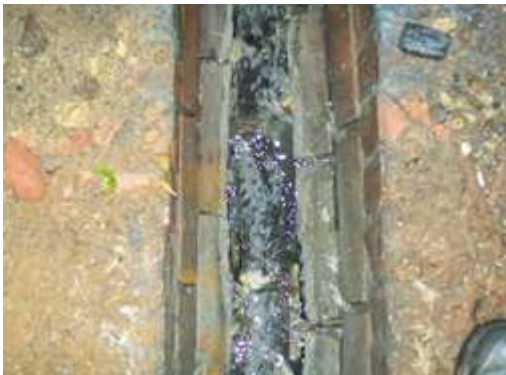
Defect 2

Condition: ☐ Sound ☐ Cracked ☐ Root Intrusion ☒ **Deteriorated** ☒ **Leaks** ☐ Debris

CHANNEL LEAKS

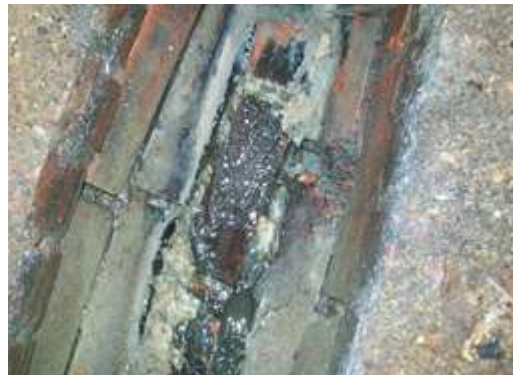
Defect 1

DETERIORATED CHANNEL

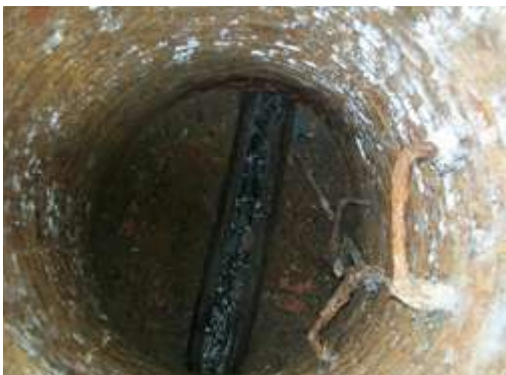
Defect 3

**Steps** Count: **3** Missing: **0** ☒ **Corroded**

Corroded Steps

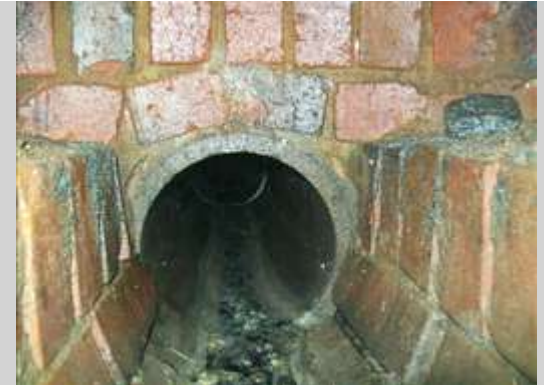
12 O'Clock Outflow

8 in. Circular Gravity Sewer  
Pipe Out @ 12 O'Clock

Pipe Height: **8.4** (in.) Rod and Bar (Angled)  
Pipe Material: **Clay** ☐ Pipe Lined  
Invert Depth: **7.20** (ft.) Flow Characteristics: **Slow**  
Deposits: ☒ None ☐ Mud ☐ Sludge ☐ Debris ☐ Grease  
Silt Depth: **0** (in.) Deposits Extent:  
Infiltration: **None** Pipe Seal Cond: **Sound**

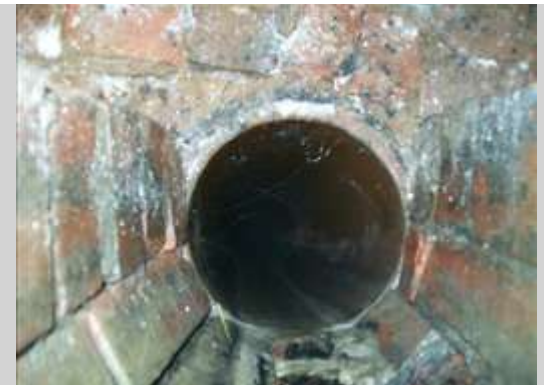
6 O'Clock Inflow

8 in. Circular Gravity Sewer  
Pipe In @ 6 O'Clock

Pipe Height: **8.4** (in.) Rod and Bar (Angled)  
Pipe Material: **Clay** ☐ Pipe Lined  
Invert Depth: **6.75** (ft.) Flow Characteristics: **Slow**  
Deposits: ☒ None ☐ Mud ☐ Sludge ☐ Debris ☐ Grease  
Silt Depth: **0** (in.) Deposits Extent:  
Infiltration: **None** Pipe Seal Cond: **Sound**
